KT16A/18A/20A/22A

Repair Manual

KT16A/18A/20A/22A SERIES

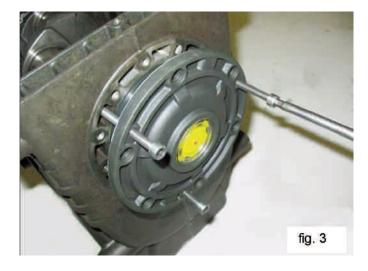
- The side covers using - for extraction 3 fully threaded M6 x 50 screws, inserting them in the threaded holes as indicated in fig. 3

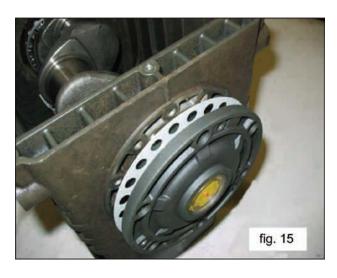
Once the type and number of shims have been determined using the table, check the following: assemble the shim pack on the indicator side cover centring (fig. 15), secure the cover to the casing, following the procedure in paragraph 2.1.2 and tighten the screws to their recommended torque. Check that the shaft rotation stall torque is between 3-4.5 Ft. Lbs.(4-6 Nm). If this torque is correct, connect the con-rods to the crankshaft and to the next stages. If it is not, redefine the shim pack, repeat the operations.

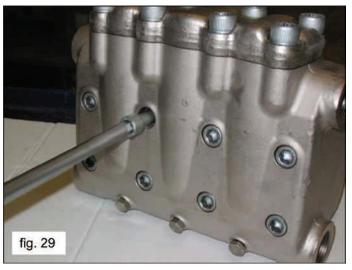
A) Unscrew the M10x140 head fixing screws as indicated in fig. 29.

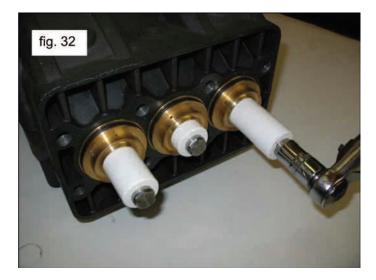
The piston unit does not require any routine maintenance. Maintenance is limited to visual checks only. To extract piston units: loosen the M7x1 piston fixing screws as indicated in fig. 32.
